Work Performed Today (April 15) in Response to the Leakage from the Underground Reservoirs

April 15, 2013

Tokyo Electric Power Company

Cause Investigation of the Leakage

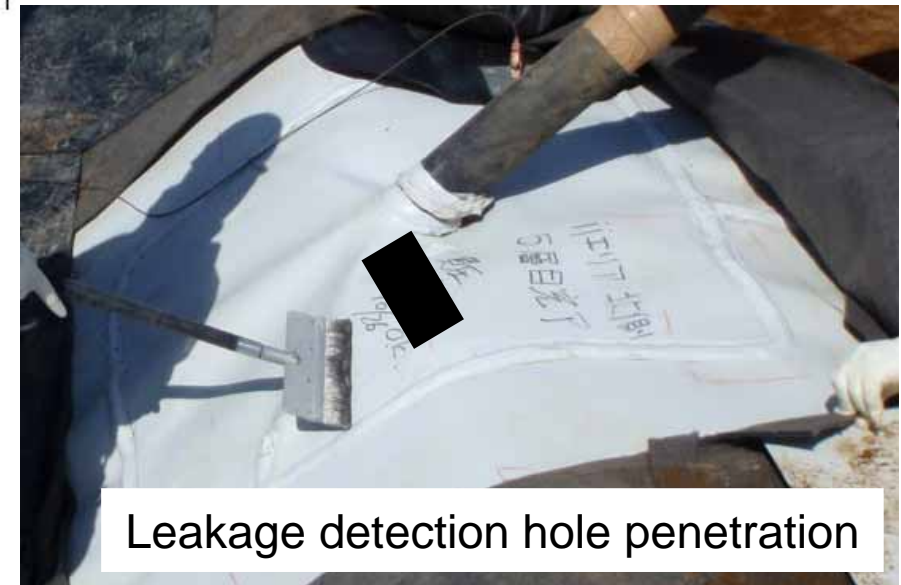
Leakage detection hole penetration

No problem was found as a result of the spark test.

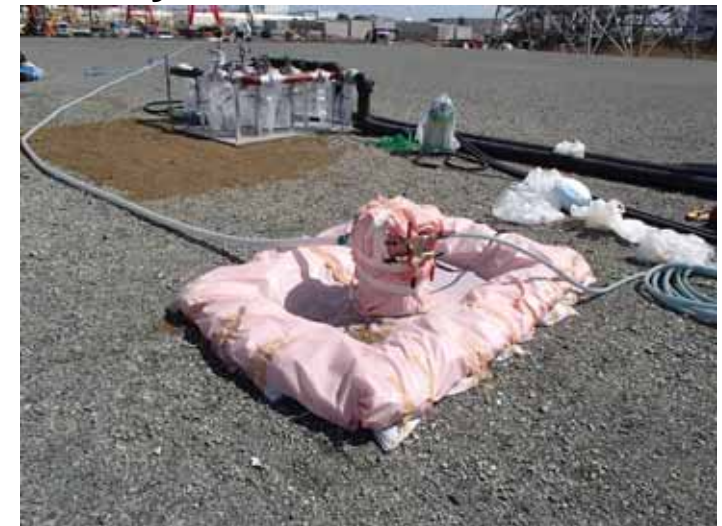
Installation of the pump at underground reservoir No. iii (photo taken on April 13)
